DON'T

OVER TIGHTEN THE SOLENOID NUT

Rolling Components Ltd

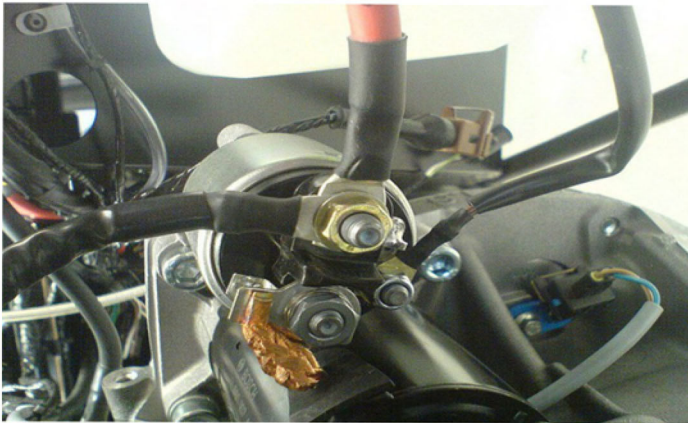
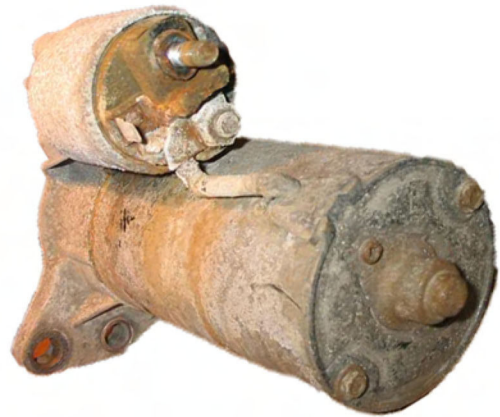
solenoid nut - tightened and snapped

Over Tightening: Excessive torqueing of fasteners can break posts or other vital components on or inside the solenoid.

(Standard Torque Recom : Energising Terminal 4-6nm, B+ 11-14nm)
