Alternators fitted with a Vacuum Pump

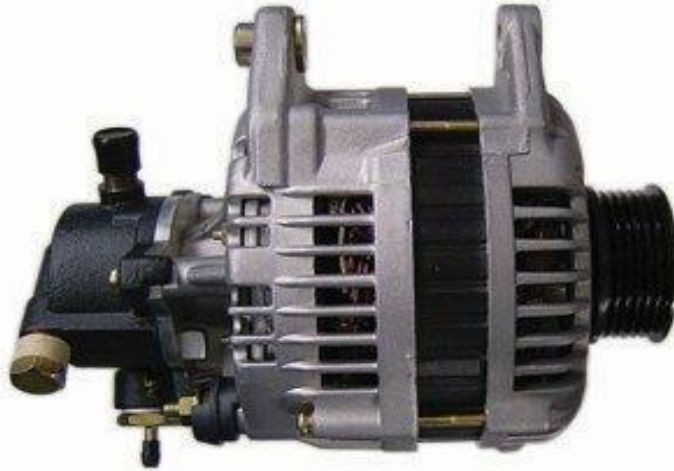
Ensure that all the connecting pipes are in the correct position and are in good condition and the pipe clamps or unions are tight. If the unions are loose the lubricating oil from the engine can escape causing an oil leak, which could have consequential damage to the engine and the alternator. In some vehicles, it is easier to remove the pump from the back of the alternator (**not recommended**) in order to get the alternator into a tight fitting space and then the pump is refitted with the alternator in situ. In some of these cases, the pump was not re-fitted correctly or the fixings tightened properly causing premature failure and engine oil loss.

THIS MAY CAUSE THE WARRANTY TO BE VOID
