Missed Dowel

STM926 / STM963 / STM965

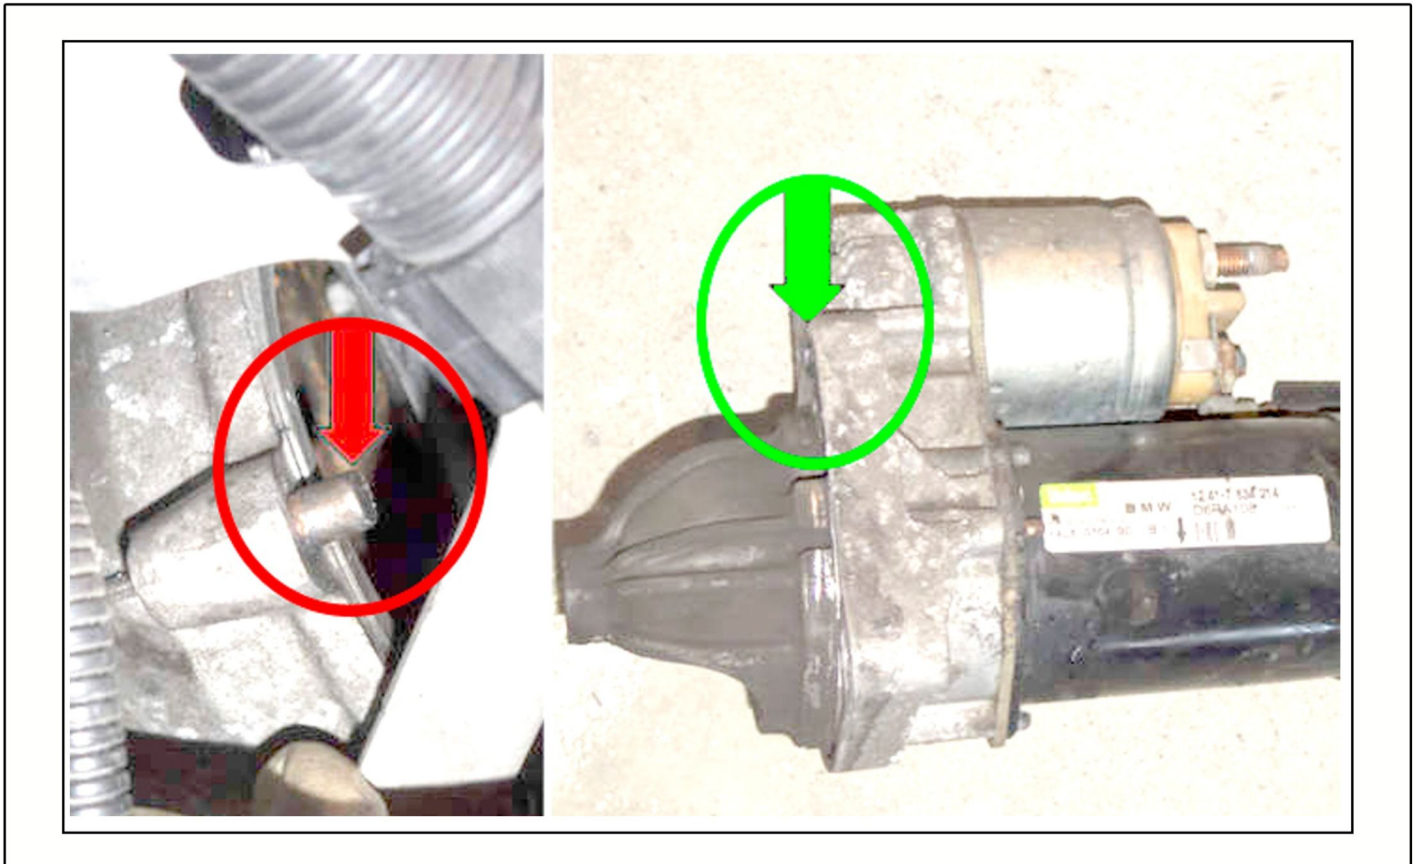
These units have a dowel which is located between the starter motor and gearbox. This allows for the unit to be aligned in the correct position. When removing the old starter motor please make sure the dowel either comes out with the old unit or removed from the gearbox and refitted to the new starter motor. If you fail to do this the unit will not align properly and will cause the unit to be very noisy or fail prematurely. If you don't follow this warning your warranty maybe void.
