## Premature Clutch Pulley Failure

ALT2014CP

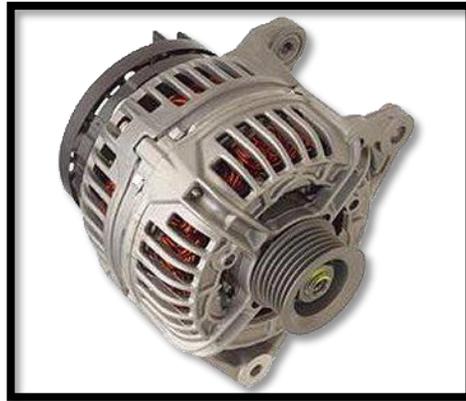
Common cause for **Premature Clutch Pulley failures** can be due to a tensioning issue but the pulley is blamed, basically the reason for the failure is due to excessive tension being applied to the pulley. Before replacing the alternator, it is highly recommended that you inspect the original old unit alternator pulley for any defects.

**A** - Please insure correct fitting procedure is followed correctly otherwise premature clutch pulley failure will invalidate your warranty. The bottom brackets must be tightened first then tighten top brackets last. If the top bracket is tightened first this will cause the adjuster on the vehicle to be out of line and will cause premature alternator failure. We recommend that you change the clutch pulley sleeve to avoid any problems later on due to wear and tear of part. If the unit is returned to us under warranty with the above condition your warranty will be void.

**B** - Check the function of the clutch pulley. If the pulley is not functioning as it should then you have a pulley failure, this indicates that a vehicle fault need investigating before the fitment of the replacement alternator as failure to do so may cause premature failure of the pulley on the replacement unit.

**C** - A rusty pulley or Tensioner will create problems of its own. If you find rust build up on the pulley or Tensioner it will need replacing. Rust bleed from the Tensioner between the arm and the base affect electrical components such as the alternator. It is recommended where possible to replace a flat spring Tensioner with a round spring Tensioner as these do not rust.
